**Arana Gulch Watershed Enhancement
Plan Phase 1:
Steelhead and Sediment Assessments,
Santa Cruz County, California**

February 2002

Balance Project Assignment 99005.08

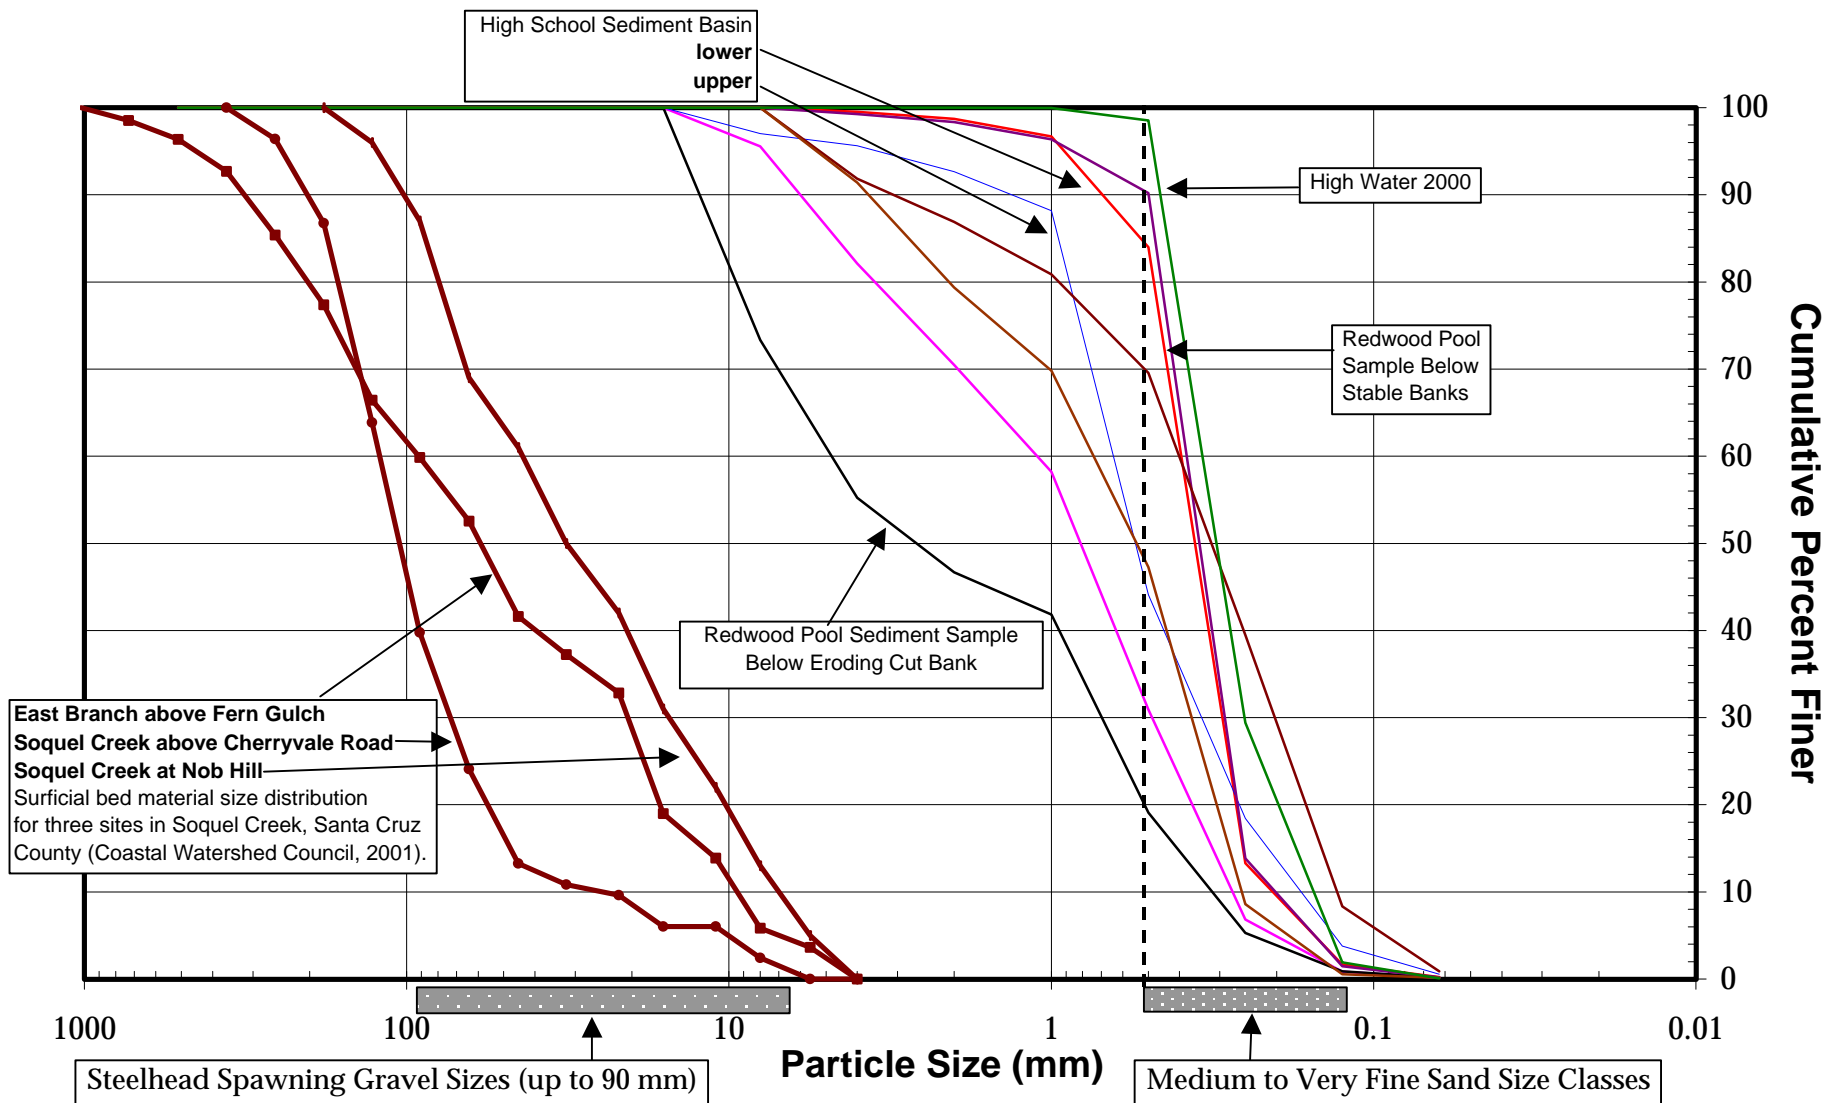
Figure ES-2: Particle-size distribution of sediment samples from the channel and high water marks of Arana Gulch.

Note that the 50 percentile for 6 out of 8 samples falls within or near the medium to fine sand class sizes and that sizes needed for steelhead spawning were found in only three samples, one being situated below an eroding road bank. Three samples collected from nearby Soquel Creek are shown for comparison. The size distribution curves illustrate that the coarsest material found in Arana corresponds to the finest size fractions sampled in Soquel Creek

Sand-sized sediment fills almost all pools, holes, and other resting places in Arana Gulch from the headwaters to the mouth at the Santa Cruz Small Craft Harbor (**Figure ES-2**). Further, riffles throughout the creek are mantled with sand. In part, the sand is intrinsic to the stream, since Arana Gulch has evolved in a sandy geologic environment; however, the extent to which sand overwhelms pools and riffles in this stream system is probably much greater than usually prevailed under natural conditions. The underlying sandstones and siltstones (Purisima Formation), as well as unconsolidated terrace deposits tend to weather to sand and silt, with very little gravel- or cobble-sized debris. Silts and clays tend to wash rapidly through this relatively short, steep watershed, leaving significant volumes of sand for the stream either to (a) transport to Monterey Bay or (b) store in its channel or floodplain.² Channel reaches situated below logjams and culverts on the eastern, central and western branches of Arana Gulch do contain gravel and cobbles, often buried beneath a foot or more of sandy sediments. For these coarser materials to provide spawning or rearing habitat, the volume of sand in the stream will need to be curtailed. The volumes of sand in the channel have been growing since the watershed has been settled, grazed, farmed, and cleared, and as the networks of roads, paths, and gullies expand. As long as the sandstone canyons are occupied, well-planned stewardship of the streams can help offset the effects of these uses.

² Most of the samples we collected of the banks of the stream, high-water marks left by recent storms, or the material filling pools and glides throughout the watershed were primarily medium or fine sand (0.125 to 0.5 millimeters) (c.f., **Figure ES-2**). Very small proportions of gravel or pebbles, and no cobble-sized sediment, were observed in any of these samples.
